Manhole Inspection Summary

Manhole # S59E__006MH

Insp Date: **7/24/08 9:22 AM**

Location Address: **4400 E Lombard St**

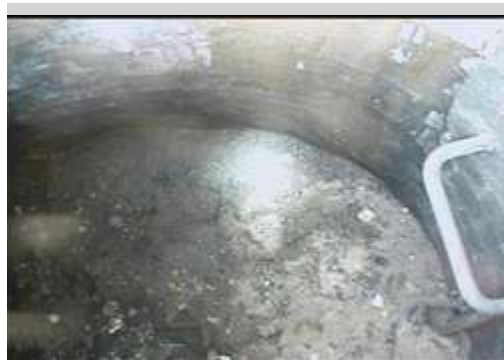
Top View

pipe out is @ 12, under shelf

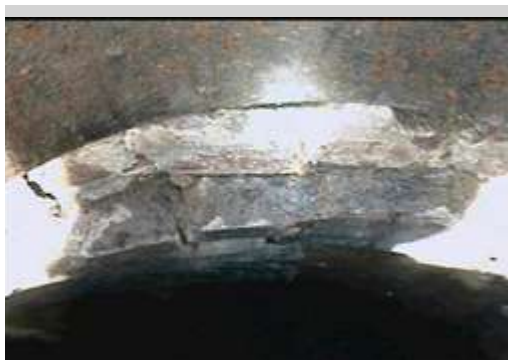
Defect 1

Condition: ☐ Sound ☐ Cracked ☐ Root Intrusion ☐ Loose Brick ☒ **Deteriorated**

chimney deteriorated and offset

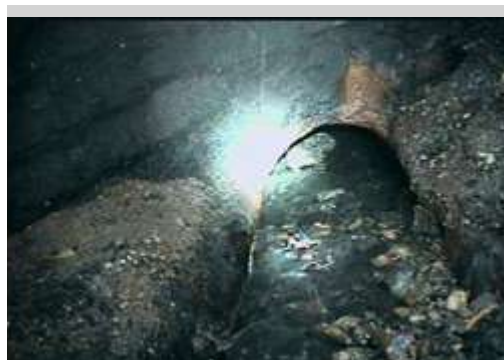
Defect 4

Infiltration: ☐ None ☐ Joint ☐ Cracks ☐ Mortar ☐ Roots ☒ **Wall**

Condition: ☐ Sound ☐ Cracked ☐ Root Intrusion ☐ Deteriorated ☐ Leaks ☒ **Debris**

barrel infiltration, channel debris

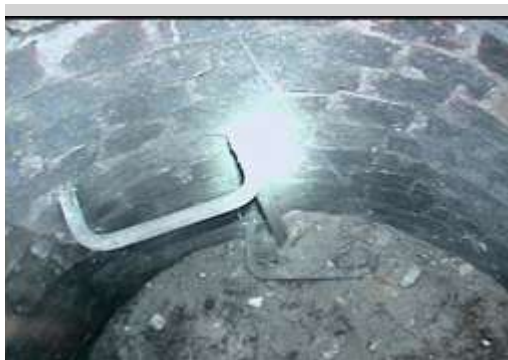
Defect 3

Steps Count: **2** Missing: **0** ☒ **Corroded**

steps

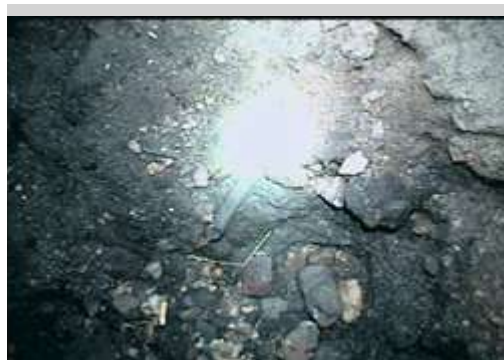
Defect 2

Condition: ☐ Sound ☐ Cracked ☐ Root Intrusion ☐ Deteriorated ☐ Leaks ☒ **Debris**

bench debris

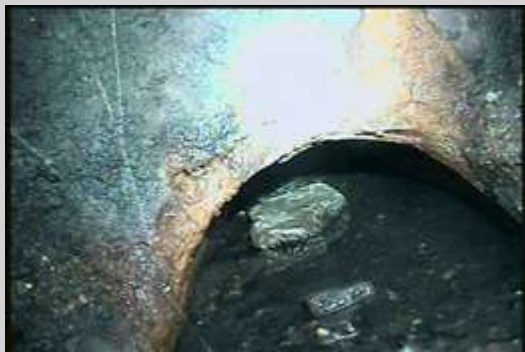
12 O'Clock Outflow

difficult angle
